Preserving Australia's Stained Glass Windows: Shedding Light on Best Practice Stained Glass Restoration and Conservation Techniques

Rebecca Kythe Boehme

Mason Family Trust Fellowship, 2026

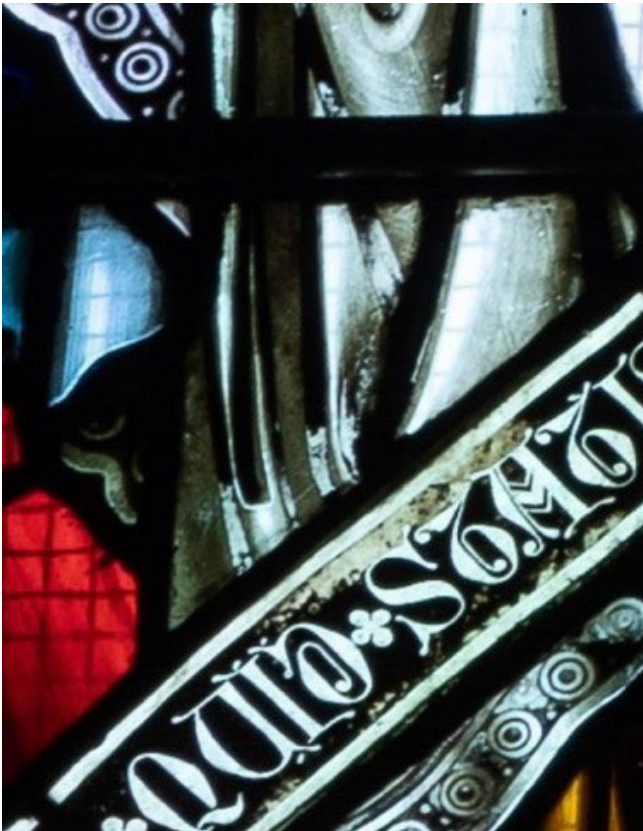
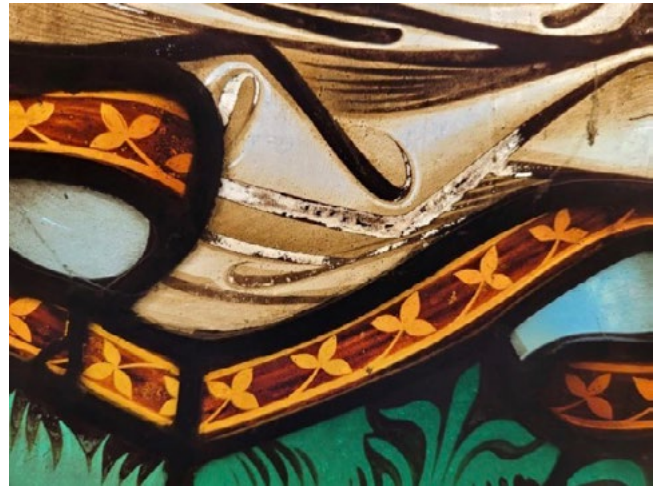
Figure 7. Image one, two and three: Paint loss detail from Hardman, Powell & Co, Great West Window in St Patrick's Cathedral, Melbourne. (Photos Courtesy of Bruce Hutton, Almond Glassworks.)

In Melbourne, paint loss is a pervasive issue for countless imported and locally produced stained glass windows. For the purpose of this report, the Fellow will focus on researching and discussing the paint loss evidenced in windows imported from Hardman Powell and Co. specifically *The Great West Window* in St Patrick's Cathedral, and the paint loss exhibited in stained glass windows produced by locally based studio Ferguson and Urie.

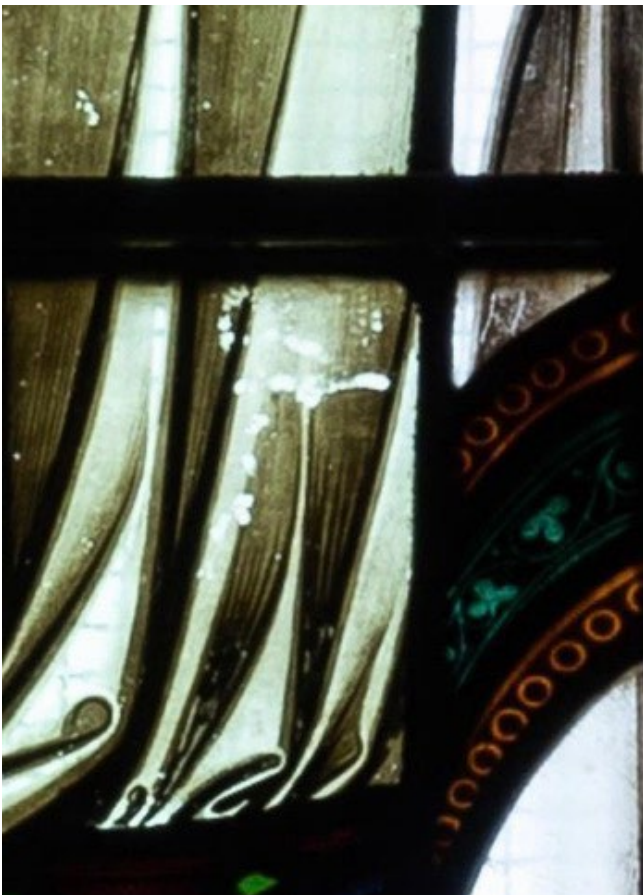
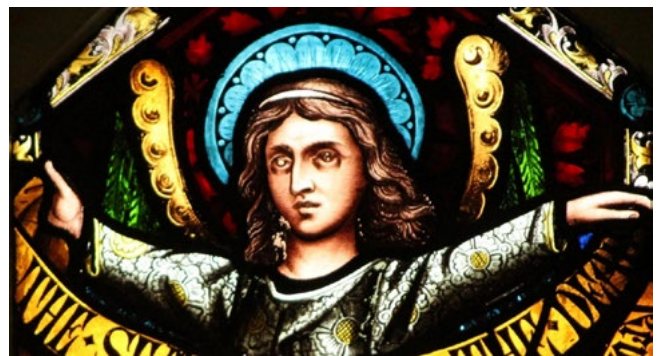
Figure 8. Image four: Paint loss detail from Ferguson and Urie detail from the tracery of St Paul's Anglican Church in Latrobe Terrace Geelong, made circa 1867. (Photos Courtesy of Ray Brown.)

As mentioned previously, a factor that could contribute to the cause of paint loss in Ferguson and Urie windows is the composition of the paint, how well it may have been originally mixed and the time and temperature at which the paint was fired onto the face of the glass. In conversation with Ray Brown, the Fellow was able to learn more about the operation of the Ferguson and Urie studio that may have led to faults in the manufacturing and firing of stained glass. Ray Brown accounts that it appears that the firm may have experienced a high turnover of kilnsmen who were not particularly proficient in

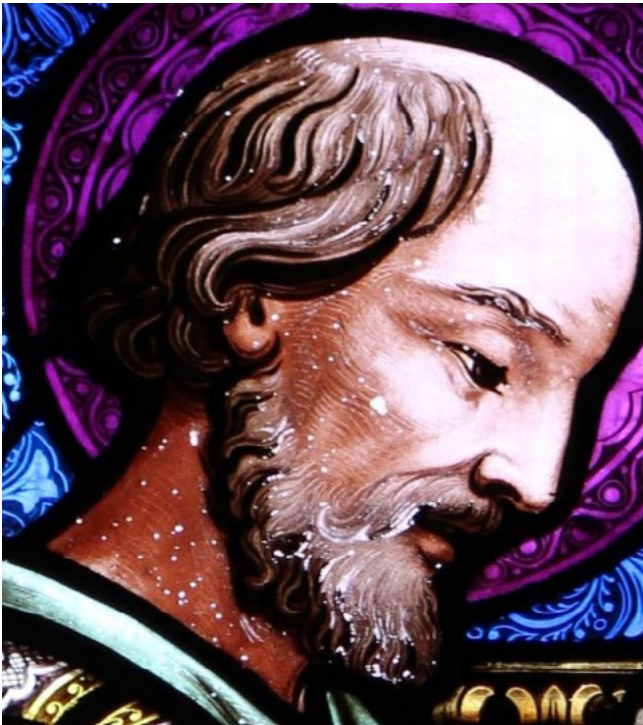
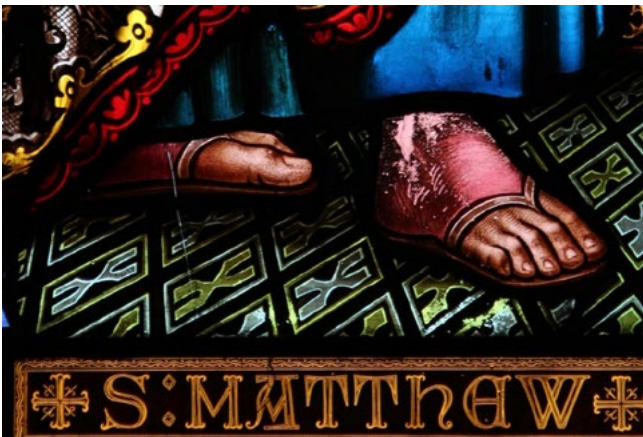
Figure 9. Image five and six: Paint loss detail from Ferguson and Urie detail from *All Saints Anglican in South Hobart*, made circa 1868. (Photos Courtesy of Ray Brown.)

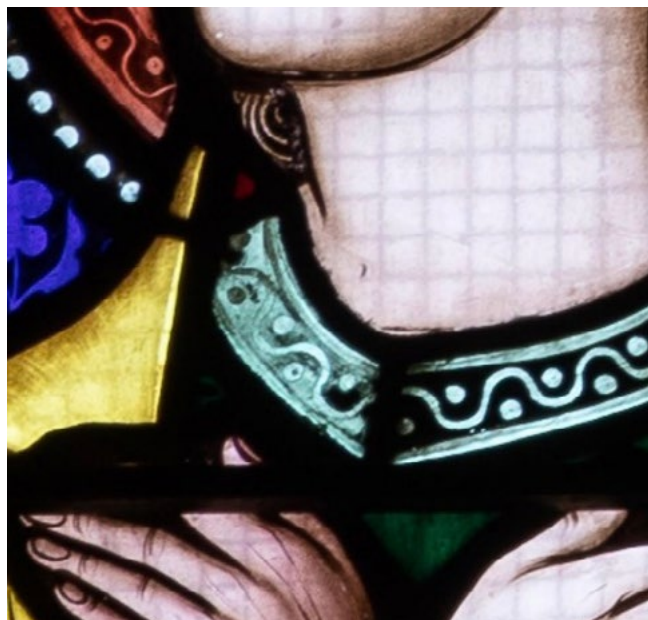
Figure 10. Image one: Paint loss detail from Hardman, Powell & Co, Great West Window in St Patrick's Cathedral, Melbourne. (Photo Courtesy of Bruce Hutton, Almond Glassworks)

identical adjacent sections of the Great West Hardman and Co. window, where one piece exhibited paint loss while the other remained intact.

In conversation with Nancy Georgi, she explained that this may be an example where two similar pieces of glass next to each other, one exhibiting paint loss and the other not, may have been similar enough in colour to be chosen to sit alongside one another, but may not be from the same sheet of glass or identically chemically composed. As discussed, soda-lime-silicate composition of glass requires a higher firing temperature, whereas a softer lead-lime-silicate composition of base glass requires a lower glass paint firing temp. The example of these adjacent pieces pictured above goes to the theory that the paint loss in these windows may be caused by the composition of base glass and inaccurate firing temperature.

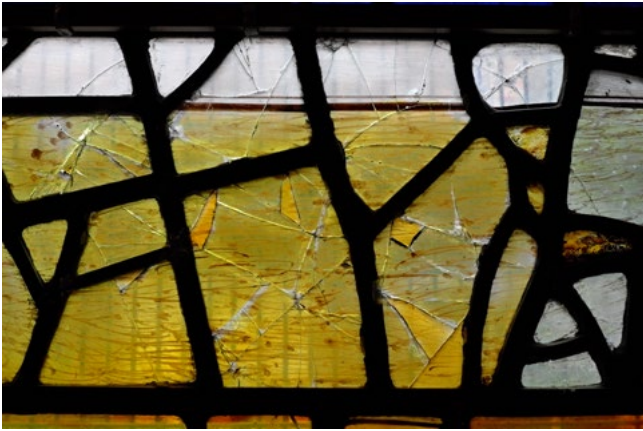
Figure 11. Edge Bonding at Merchant Taylors Hall, York.

Different types of conservation adhesives have been used by studios throughout contemporary conservation history to restore and secure breaks in glass. These materials include various types of industrial glues, epoxy resins, ultra-violet acrylic resins and silicones. Scientific research into the performance of these materials is detailed in the 1999 research report "*Conservation: Materials and Methods*," published by the Corpus Vitrearum in 2000, Jägers, Römich, and Müller-Weinitsche, stating in its conclusion that investigations indicate that dual component epoxy resins are most commonly used for fixing breaks, due to their strength, long-lasting adhesive qualities, ease of application and drying time.¹² Below is an example of edge-bonding at Merchant Taylors Hall in York, where there has been significant damage to historical pieces of glass, however conservators have been able to maintain and preserve as much original material as possible.

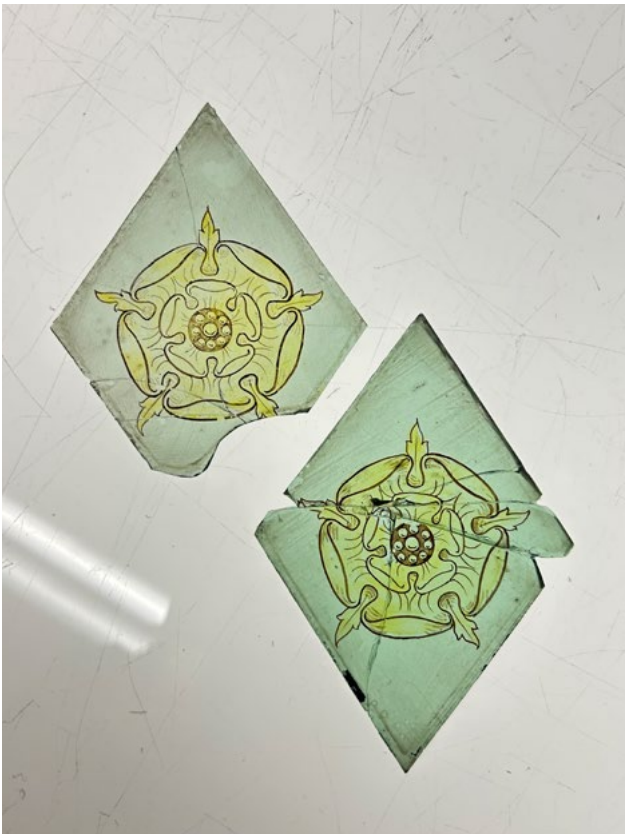
Figure 12. Image one: Edge bonding achieved with CAF 3 silicone at Barley Studios

During their placements at both York Glaziers Trust and Barley Studios, the Fellow had the opportunity to undertake edge-bonding with several different materials. **Araldite 2020**, **hxtal**, **Silcoset 153 silicone** and **CAF 3 silicone**. Information and application information for Araldite 2020 and hxtal, can be found in Appendix 3. Information and application information for CAF 3 silicone and silicoset 153 can be found in Appendix 4.

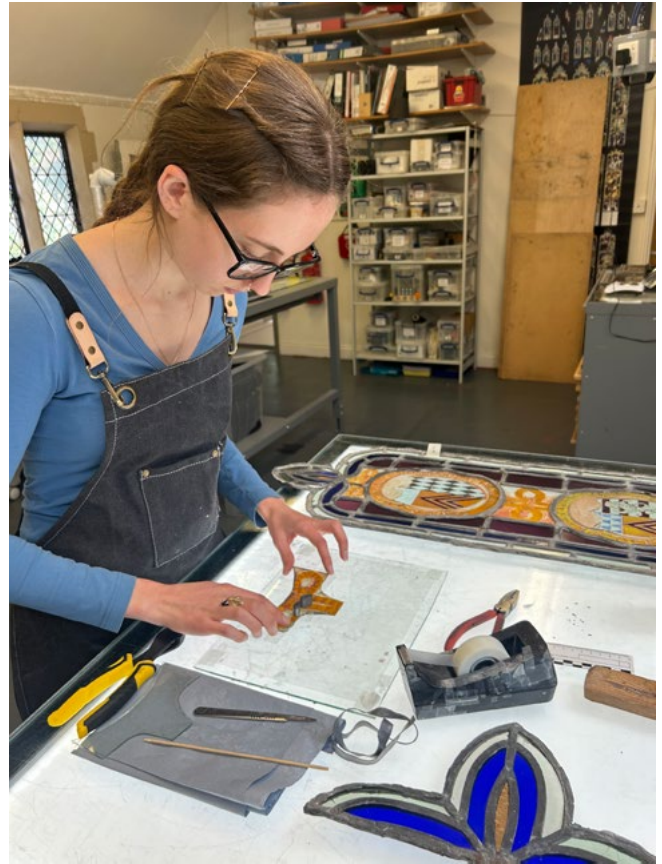
Figure 13. Image two: Edge bonding with Araldite 2020 at York Glaziers Trust, photo courtesy of York Glaziers Trust

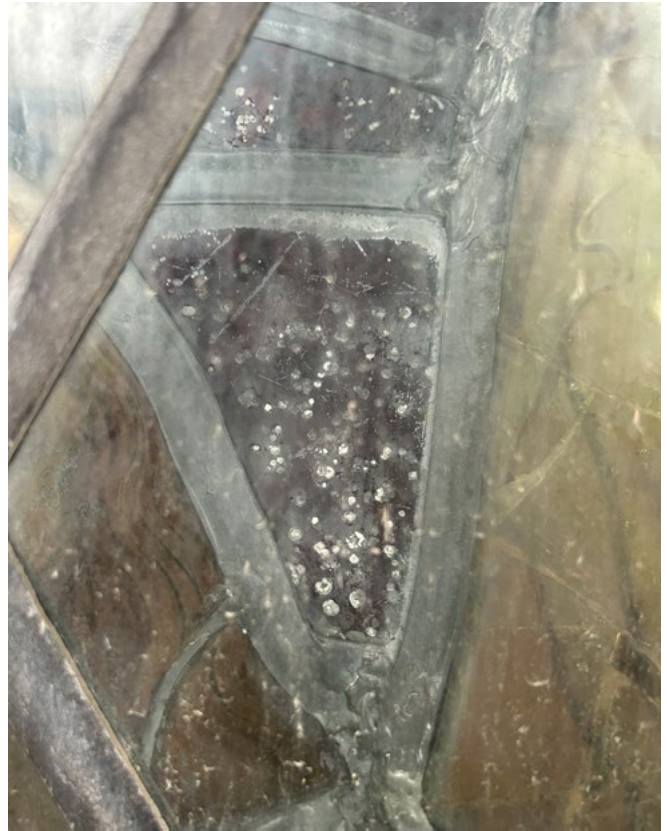
Figure 14. Medieval glass corrosion at York Minster

Corrosion on glass often appears as an iridescent sheen or etched droplets on the surface of the glass. Advanced corrosion can appear as deep pits across the face of the glass (pictured below.) Corrosion is mostly evident in very old glass, and can result from repeated cycles of dampness, wetting, and drying corroding the glass. In some cases, corrosion arises due to the instability of the base glass itself. Evidence of this would be if all pieces in a stained glass window of a particular colour exhibit signs of corrosion, this is likely linked to the chemical composition of that glass type. Many of these unstable pieces may no longer exist today, as earlier restorers may have replaced them with more stable glass. Advanced corrosion as shown below is a much more common issue with unstable medieval glass, and therefore, occurs less frequently in Australia due to the age and composition of more modern glass.

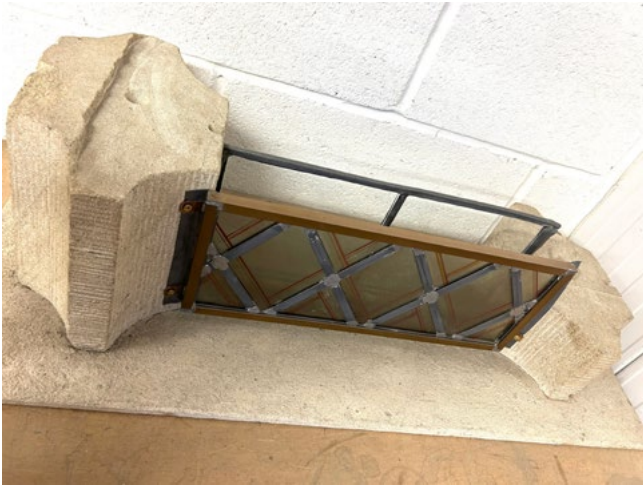
Figure 15. Internally ventilated model: note the framed historic stained glass fixed to the internal masonry, with an external protective glazing panel separated by a ventilated interspace.

As part of the design, once the framed historic stained glass is installed onto the profile of the masonry, there is a ventilation gap at the top and bottom of the panel that allows internal air to circulate through the interspace between the stained glass and protective glazing.

Airflow in this gap is bi-directional depending on internal and external conditions. When the interspace air becomes warmer and more buoyant than the indoor air, the air rises, creating a partial vacuum that draws cooler air in through the bottom vent and ejects warmer air through the top. Conversely, when the interspace air is more cool and dense, usually due to colder external conditions, the air sinks, pulling air in from the top and out through the bottom. Below are images of a model of an internally ventilated system, provided by Barley Studios.

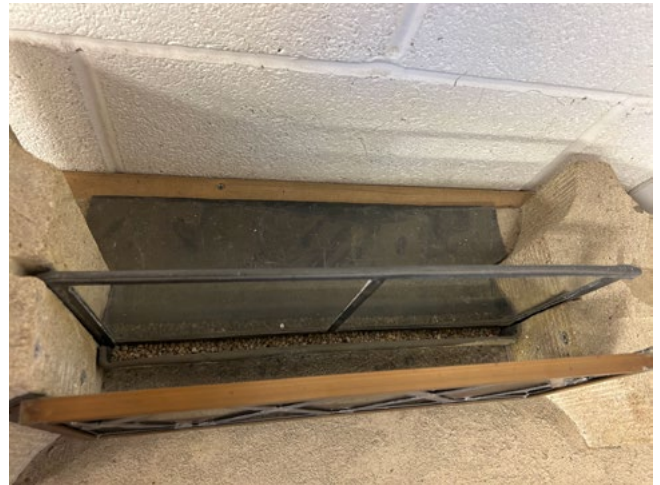
Figure 17. a top down view of the internally ventilated EPG model. Including the lead upstand filled with pebbles and the lead flashing positioned out and down the external face of the masonry.

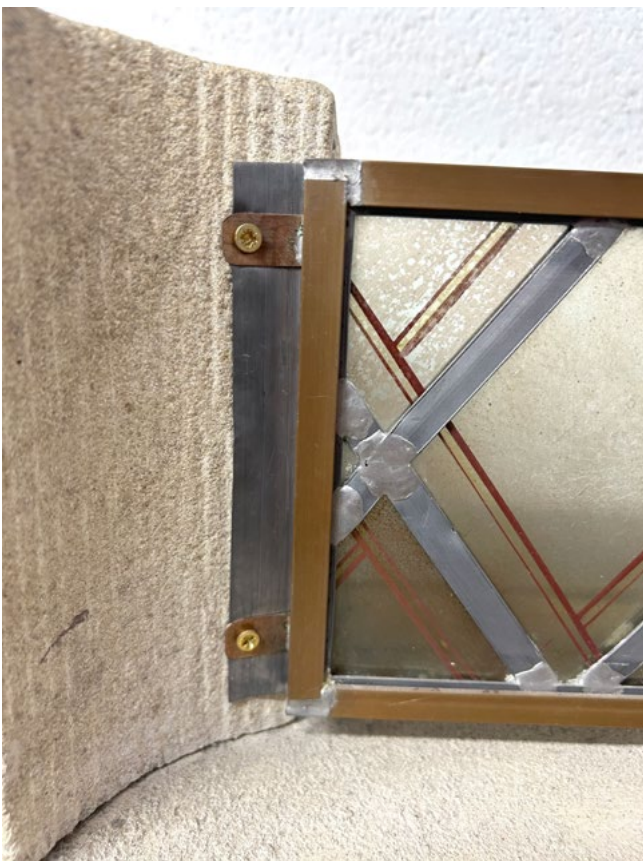
Figure 16. This close-up shows the lead flashing and copper tab fixing system used to secure the frame to the face of the masonry.

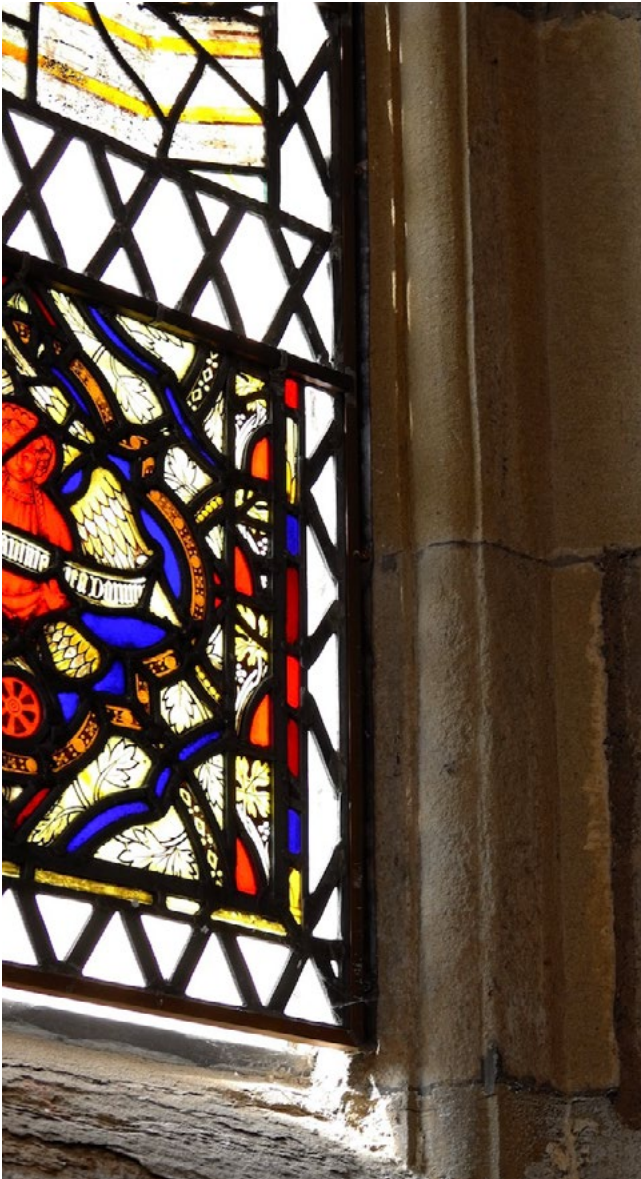
Figure 18. Image one: Internally ventilated EPG system

The images below exhibit examples of internally ventilated EPG systems in historic buildings across England. Image one demonstrates a side view of an internally ventilated panel, where the bottom bronze manganese frame, ventilation gap, and overlapping lead are visible.

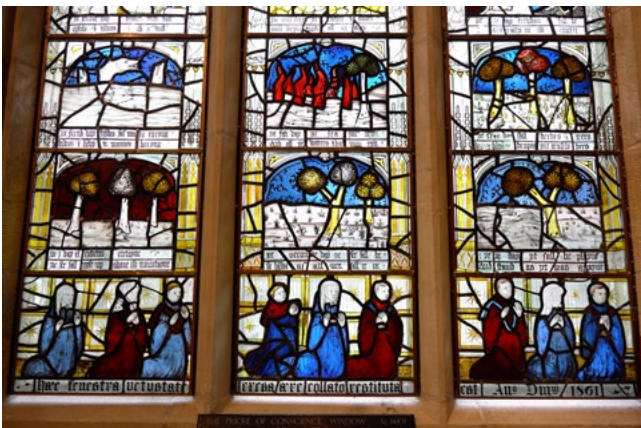
Figure 19. Image two: Pricke Of Conscience stained Glass window at All Saints, North Street, York.

Image two depicts the 'Pricke of Conscience' stained glass window located at All Saints North Church, York. Painted in 1410, this window was recently restored by Barley Studios. This image shows how from a front view, it is visible how in an internally ventilated system, each panel is individually framed, stacked onto one another and secured to the masonry.

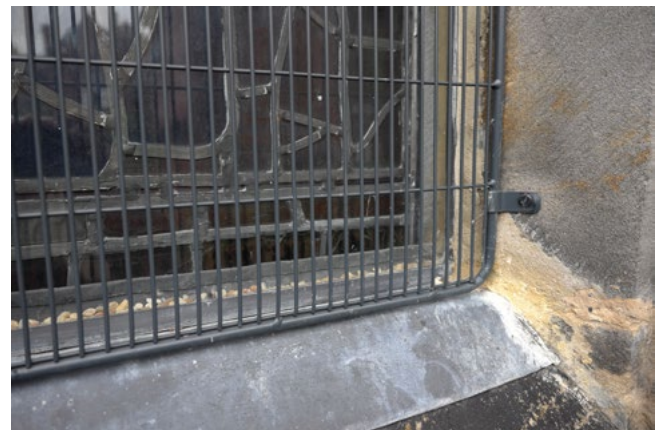
Figure 20. Lead upstand pictured in EPG system installed by Barley Studios.

The goal of an internally ventilated EPG system is for condensation to form on the face of the protective panel, opposed to the painted face of the historic stained glass. Even though the interspace is partially enclosed, any condensation forming on the protective glazing panel should evaporate quickly, provided there is sufficient airflow to allow the moisture to dissipate into the drier indoor air. Alternatively, depending on the building conditions, the system is designed so that excess condensation can run down the face of the protective panel and collect in a lead upstand positioned at the base of the panel (pictured above and below). This trough is filled with small pebbles or glass beads to ensure it does not fill with dust and debris. This trough extends underneath the border lead of the protective panel, and flares out over the external masonry sill, so that the condensation that drips down the face of the protective panel and into the trough is channelled outside and down the face of the lead flashing where it safely evaporates into the external outside environment.

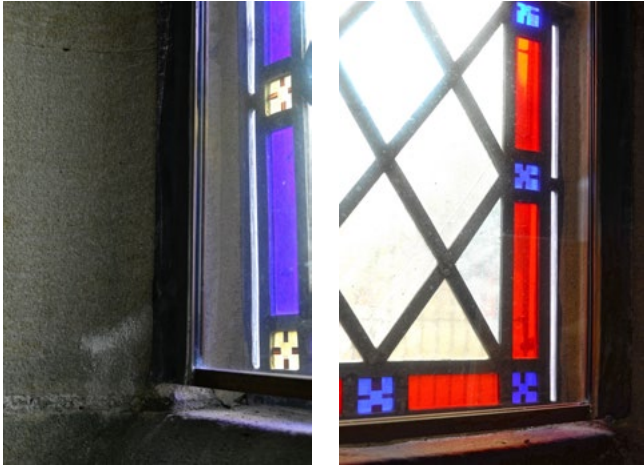
Figure 21. internally installed environmental protective glazing in-front of quarry leadlights, installed by Barley Studios.

Another type of internally ventilated EPG is where the original stained glass remains undisturbed in its original groove. The protective glazing panel is secured inside a frame and is installed onto the internal face of the masonry profile, again being screwed into the stone through copper tabs. Similarly to the internal system described above, a ventilation gap is left at the top and bottom of the internal panel where air can flow through the

interspace. This second method is only installed for the purpose of insulation of the building, as the design still leaves the possibility for condensation on the face of the historic glass, therefore making this method only appropriate for leadlight.

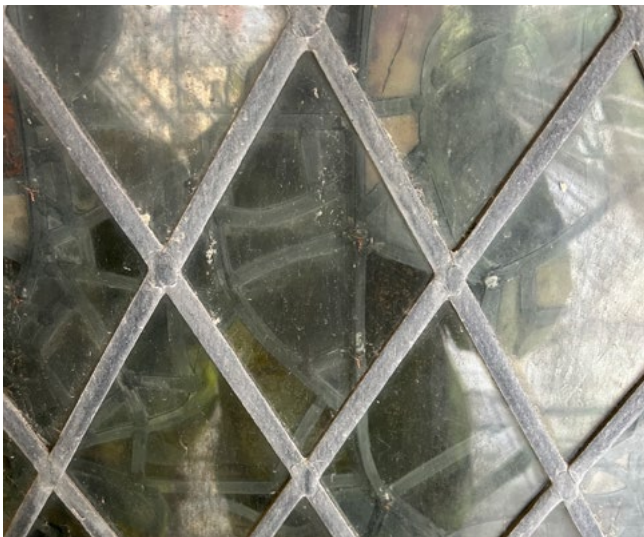
Figure 22. Historical stained glass environmental protective glazing with quarries on York Minster.

Part of the Fellow’s research was understanding the different styles of protective glazing panels used in EPG systems. In early productions of protective glazing, it was common for the protective panel to be manufactured with diamond quarries, irrespective of the historic glass that lay behind it. Currently, there are many more options.

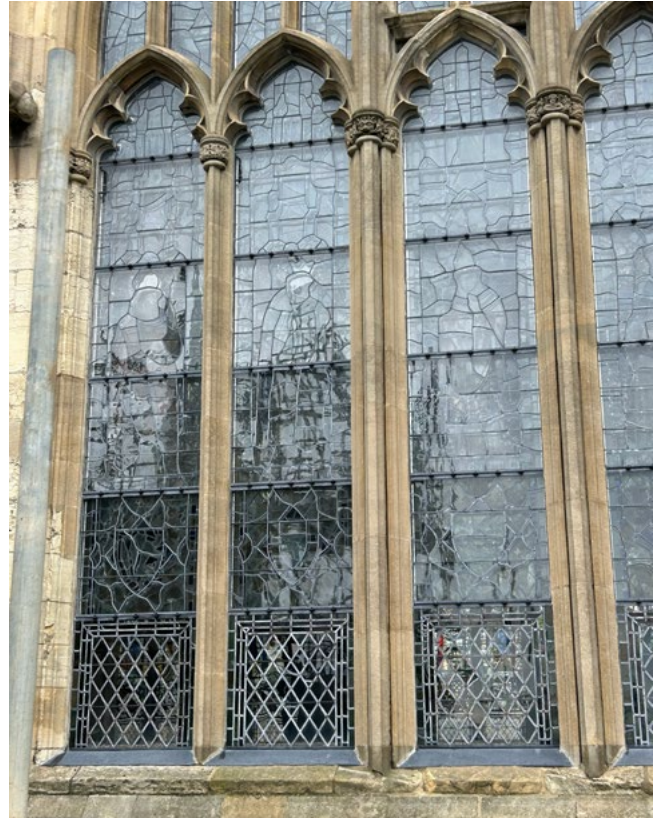
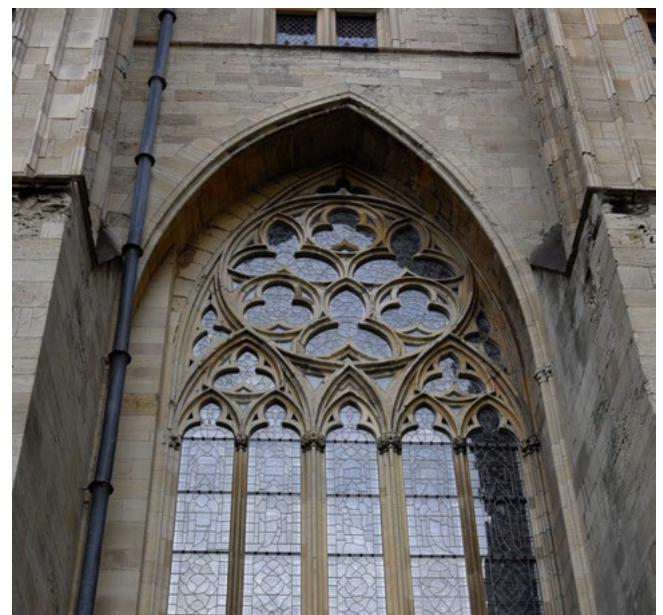
Figure 23. stained glass environmental protective glazing on York Minster by York Glaziers Trust.

At York Glaziers Trust, the Fellow learned how to produce protective glazing panels that use the lead matrix of the historic window as a template, constructing the new panel with lead lines that replicate the original design.

Advantages of this system is that it maintains the aesthetics of a stained glass window from the outside of the building, as shown in images above. However there are some arguments against this method due to the risk of seeing double lead lines or, 'paralax' when looking up through the stained glass window. This can be reduced by careful planning and considering the distance between the stained glass and protective glazing, the height of the window and how acute of an angle the viewpoint is. It is possible to install the protective panels with these factors in mind, so the internal lead lines of the protective panel more accurately line-up with those of the internally secured historic stained glass. The type of glass that York Glaziers Trust uses for their protective panels throughout much of York Minster is Lamberts Restauero UV resistant glass, which is discussed in detail below.

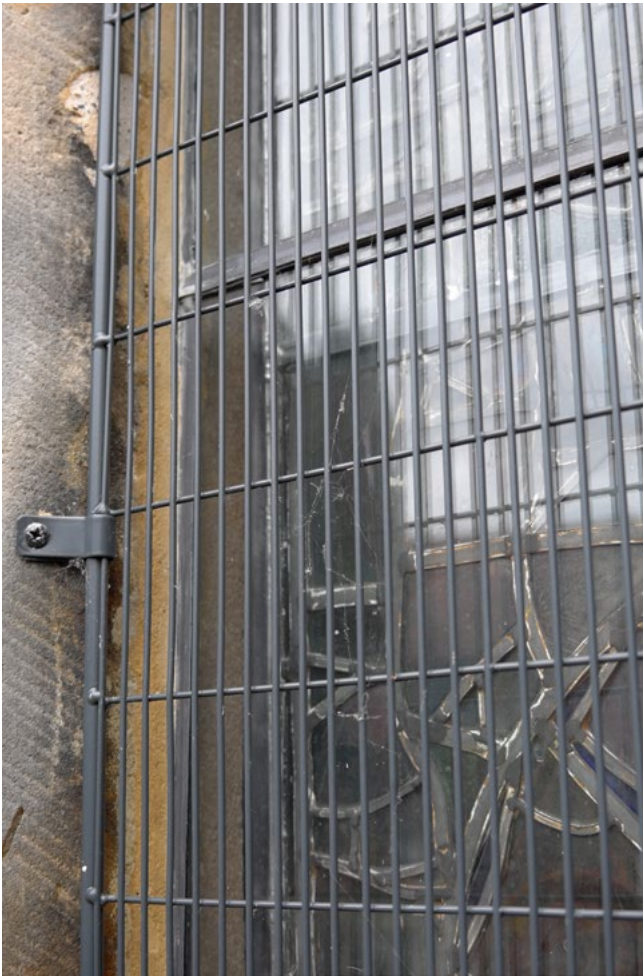
Figure 24. Detail of powder coated protective screens over environmental protective glazing at All Saints North Street, York. Environmental protective glazing by Barley Studios.

In addition to this, EPG assists in protecting the stained glass from vandalism, which the Fellow has also noted as a pervasive issue in Australia. EPG designed to reduce instances of vandalism can be delivered either through laminated protective panels or with the addition of conventional wire screens. Which option is chosen depends on several site-specific factors. First being the aesthetic of the painted glass that is being protected. Laminated panels are generally preferred where the stained glass painting is light in tone or minimally painted, as wire screens would be more visually intrusive in such conditions. The location of the church is also a key consideration. Buildings that may be situated away from public view, wire screens may be acceptable, whereas high-profile churches in prominent settings typically benefit from the more discreet appearance of clear laminated protective panels. Additionally, if existing screens already exist for mechanical protection, their retention is often the most cost-effective approach when compared to the installation of laminated protective panels and especially in place of the use of toughened Lamberts restoration glass.
