# Historical Wall Coverings and Wallpaper Restoration

## **Paul Bramley**

ISS Institute/TAFE Fellowship

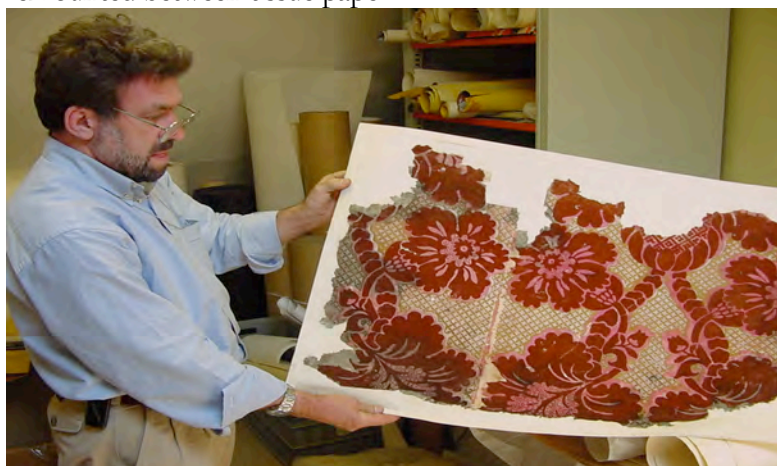
Treve Rosoman showing a rare double flocked pattern on joined paper.

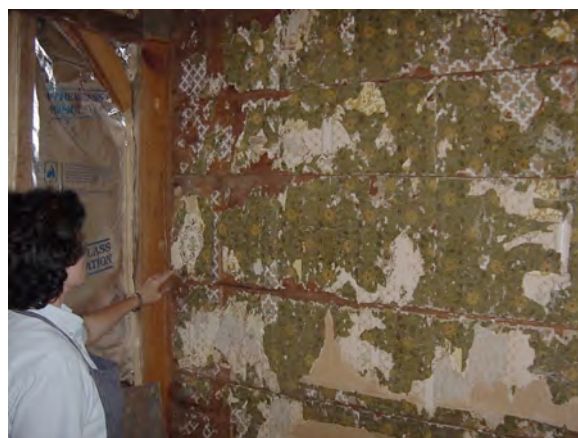
Papers are printed with distemper paint from hardwood – surfaced blocks. The result is authentic wallpaper with patterns taken from the collections of American museums and historic sites.

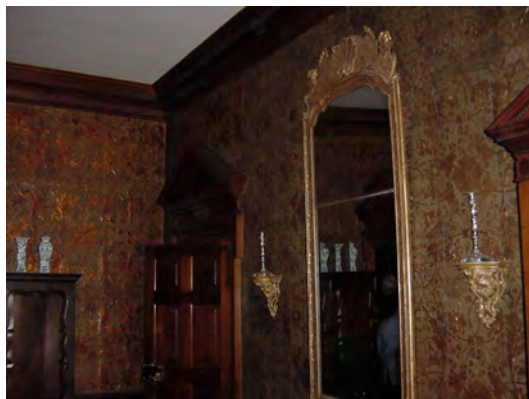
Existing leather wall covering internal walls Governors Palace in the upstairs middle room.

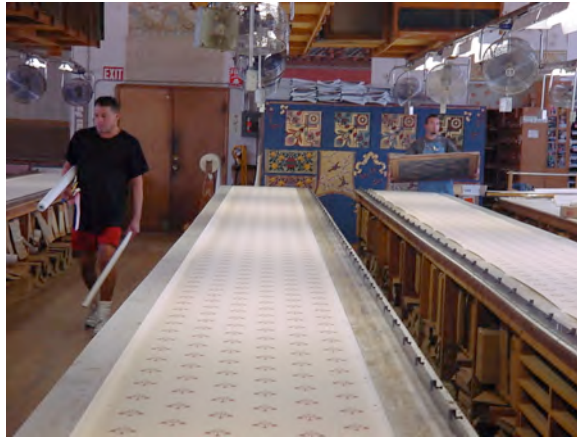
Benches with complete roll ready for printing.

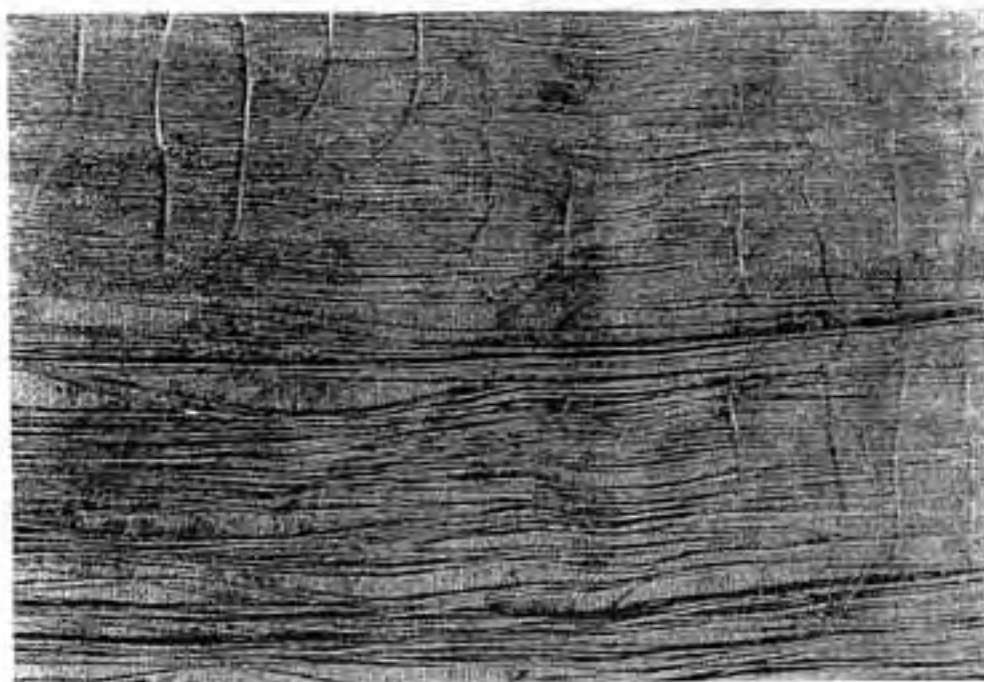
- Fig. 5: Detail of a panel originally conserved by couching with silk threads. The couching has disintegrated and remains of the warp face can be seen on the linen support.

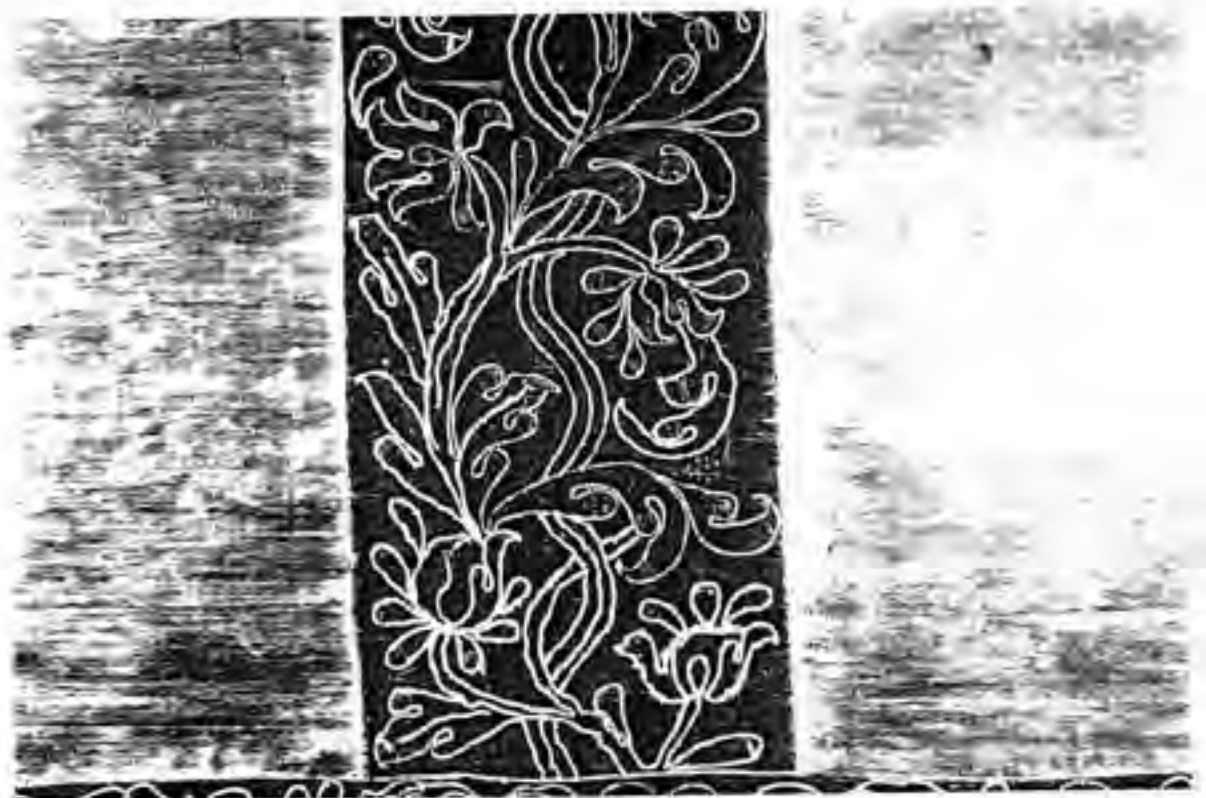
Fig.6: Detail of two panels from the section facing the windows after recent conservation. On the panel on the left, the weft has been re-attached using carboxymethylcellulose. On the panel on the right, the final stage, covering with Stabiltex, has been completed.

The panels were then covered with dyed polyester gauze (Stabiltex 0). Because the original stitching connecting the panels to the hangings was removed in the early conservation work it was possible to release short sections (20cm) at a time on either side of each panel and take the edges of the Stabiltex around the back, finally restitching both the covering and the damask panel to the sound interlining of the hanging. Four of the panels were completely enclosed, but only two thirds of the central panel was covered, leaving the sounder unfaded section of damask exposed. Stabiltex was chosen for its durability; it has a more crystalline structure than nylon and is thus more resistant to photodegradation and chemical attack; the condition of these panels is such that the present work cannot be modified within the foreseeable future. Stabiltex is denser in appearance than nylon tulle but its visual appearance is quite acceptable when used vertically.

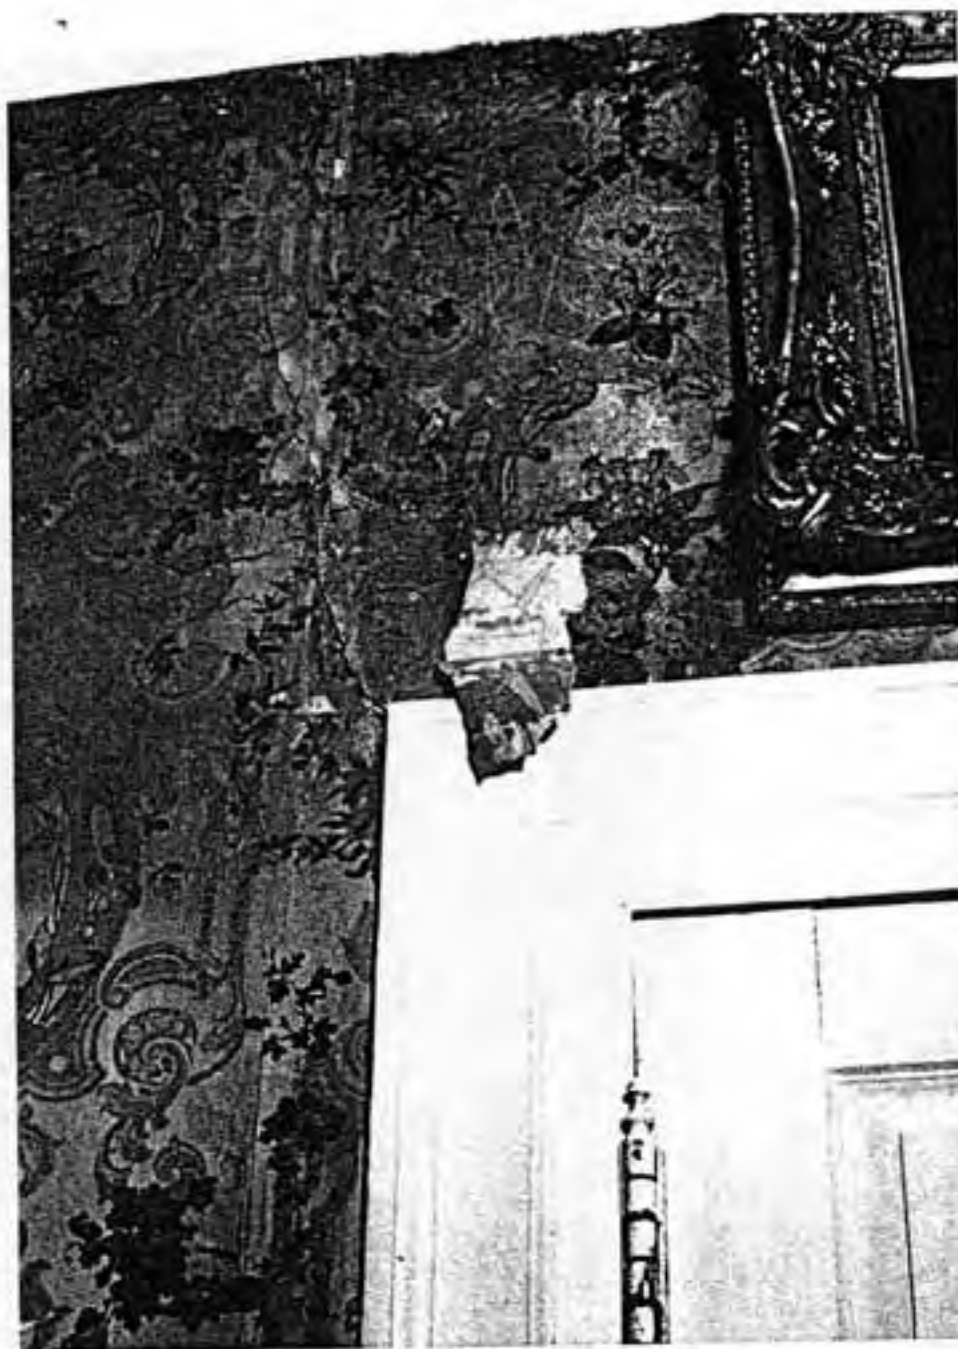
FIG. 2 Parlor paper before treatment. Detached flap exposing underlying paper. Tears in paper along plaster cracks evident in area left of flap. Waterstaining along top edge.

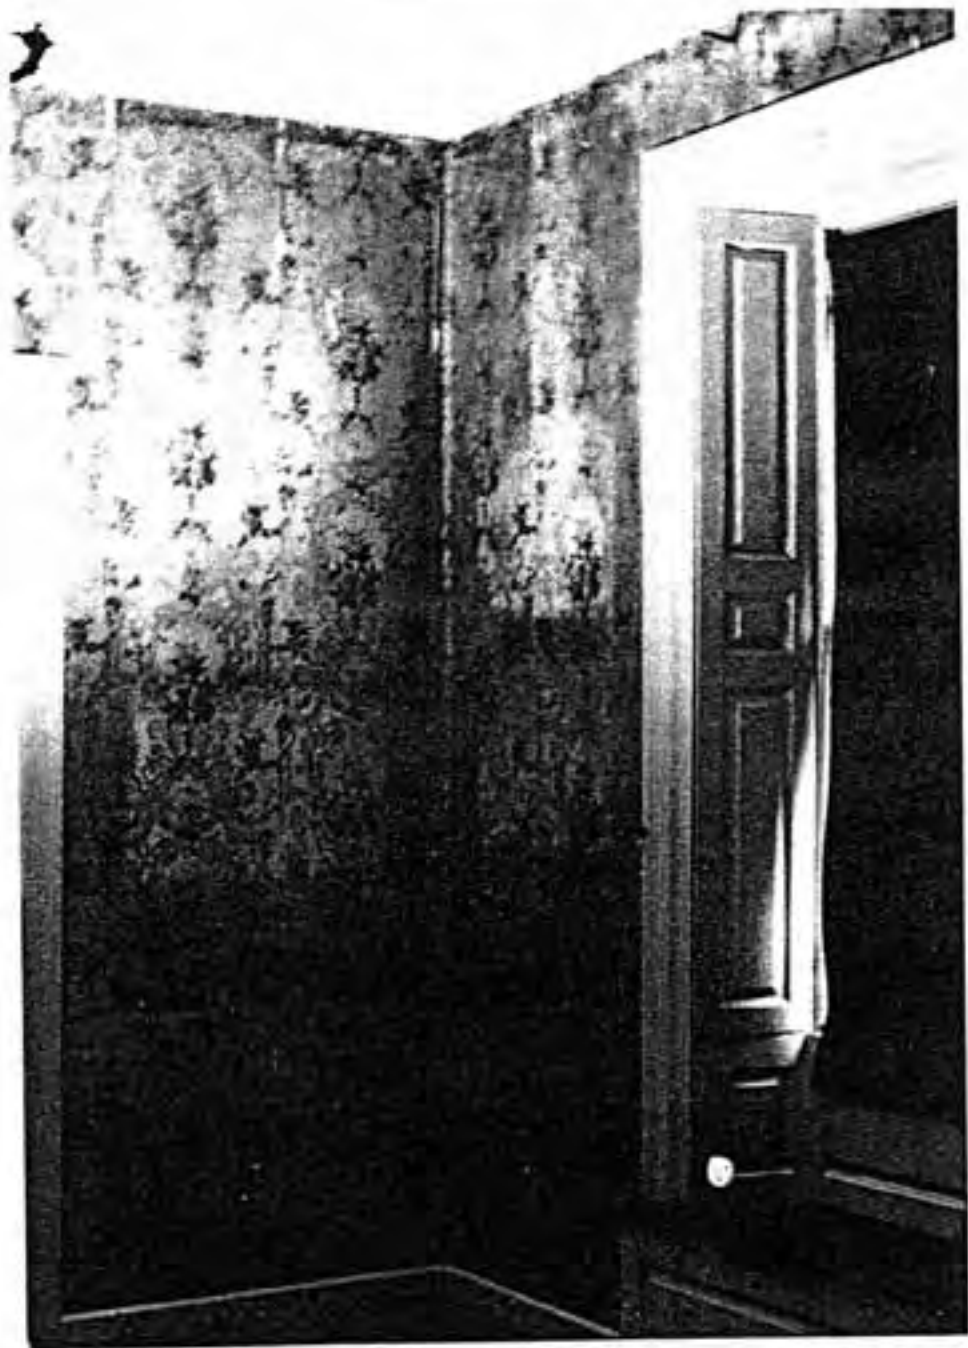
FIG. 3 Parlor paper before treatment. Heavy dirt and soot accumulation. Design loss from furniture abrasion at lower left.
